**Technical Reports:
Visual Inspection-Adhesion Failure**

POINTek, Inc.

- This Document Presents the **Visual Qualification/Reliability Analysis for the POINTek's Assembly Process: Reliability Inspection of Proprietary Adhesive Curing Process Coupling of Single Mode Fiber Array into PLC Splitter Chip.**
- Most of Device Failures (> 95%) in Planar Optical Devices Are Initiated from the Fiber Arrays and Their Interface to Chip Coupling.

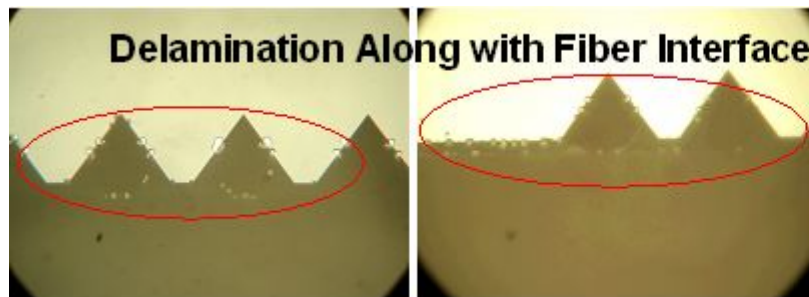
672Hrs at 43°C Water

- ✓ Delamination Patterns Were Initiated from Non-Reliable Fiber Array Attachment.
- ✓ Conventional Product Shows Minor Delamination Problem in Pigtailed-Facet Interface after 672Hrs (28 Days) at 43°C Water, and Delamination were Found to Be Growing after 1512Hrs (63 Days).
- ✓ No Sign of Surface Delamination in POINTek's Sample after 1512Hrs (63 Days).

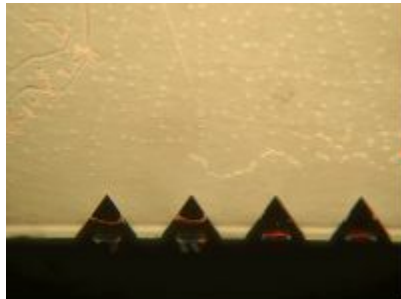
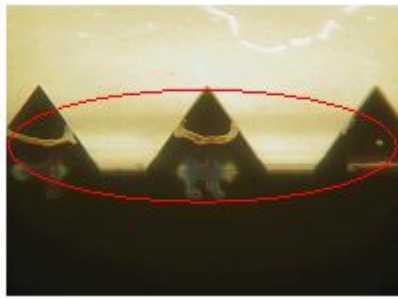
~ Days at 85°C/85% RH

- ✓ Due to the Pigtail Process Failure of the Conventional Product, Major Delamination Problem Was Inspected after 24Hrs at 85°C/85% RH.
- ✓ No Sign of Delamination in POINTek's Sample after 72Hrs (3 Days) at 100°C Water.
- ✓ Very Minor Sign of Delamination in POINTek's Sample after 216Hrs (9 Days) at 100°C Water.
