**Technical Reports:
Visual Inspection-Adhesion Failure**

POINTek, Inc.

- This Document Presents the **Visual Qualification/Reliability Analysis for the POINTek's Assembly Process: Reliability Inspection of Proprietary Adhesive Curing Process Coupling of Single Mode Fiber Array into PLC Splitter Chip.**
- Most of Device Failures (> 95%) in Planar Optical Devices Are Initiated from the Fiber Arrays and Their Interface to Chip Coupling.

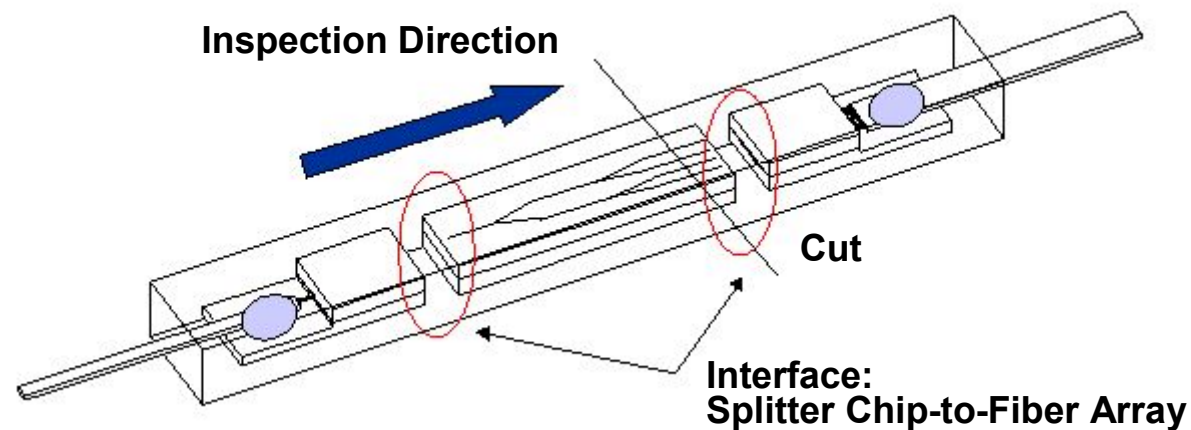
- ◆ Delamination Issue
 - Aging Condition
 - 43°C Water Immersion Storage Test
 - 100°C Water Immersion Storage Test
 - Inspection at the Interface of Splitter Chip-to-Fiber Array
